# NAVAL POSTGRADUATE SCHOOL

# THESIS

**STRESS RELIEF CRACKING IN  
COPPER-PRECIPITATION STRENGTHENED  
HSLA-100 STEEL**

Steven A. McNutt

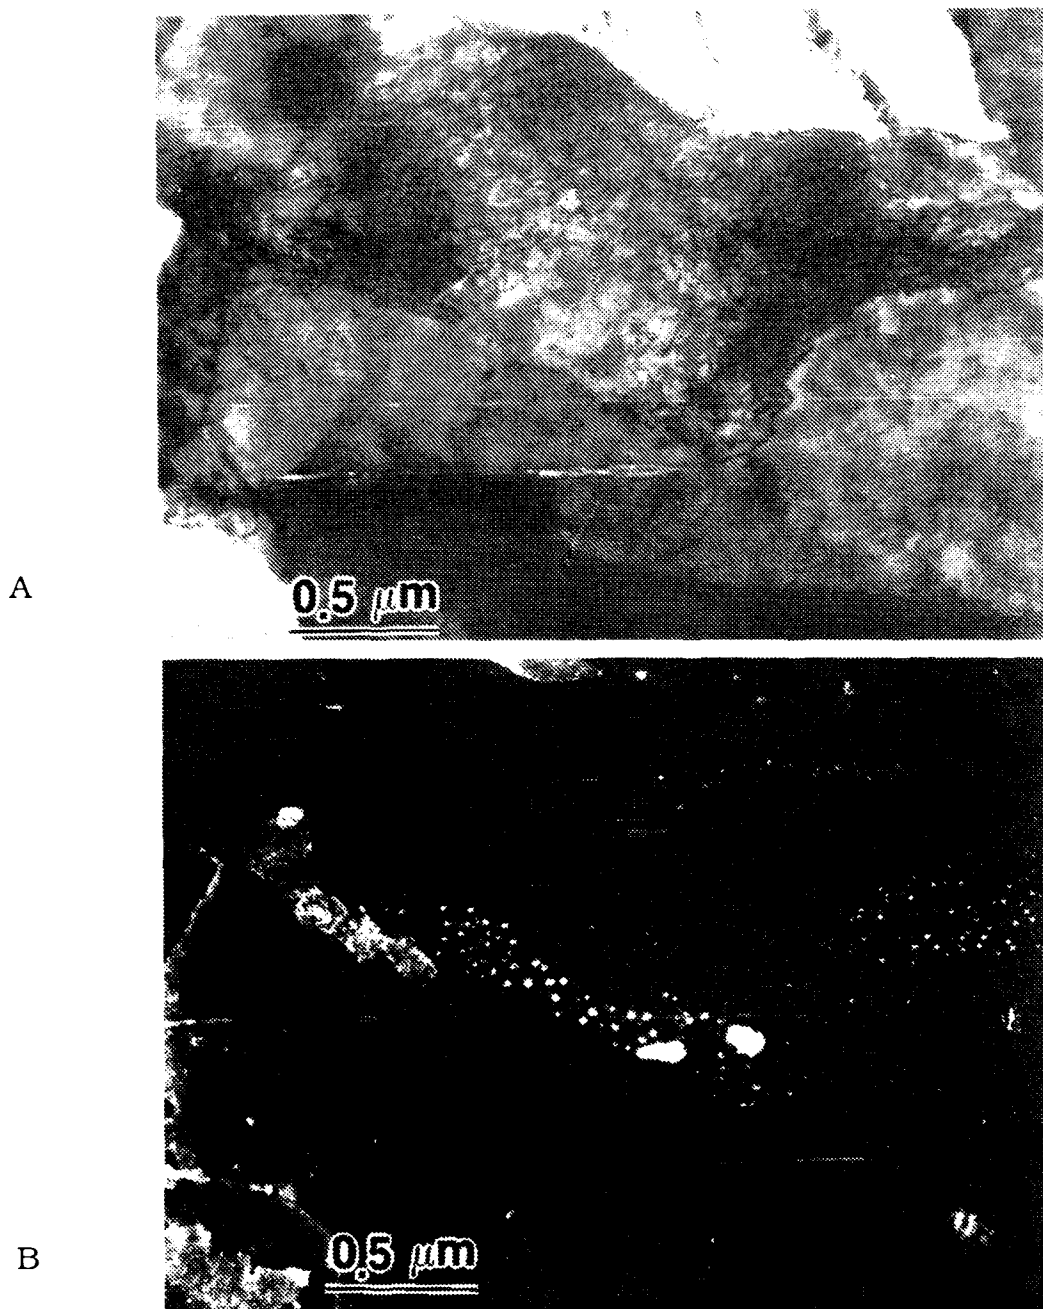
Figure 36. A **Bright Field Micrograph of a Grain Boundary Near the Fusion Line After Stress Relieving for One Hour at 650° C**

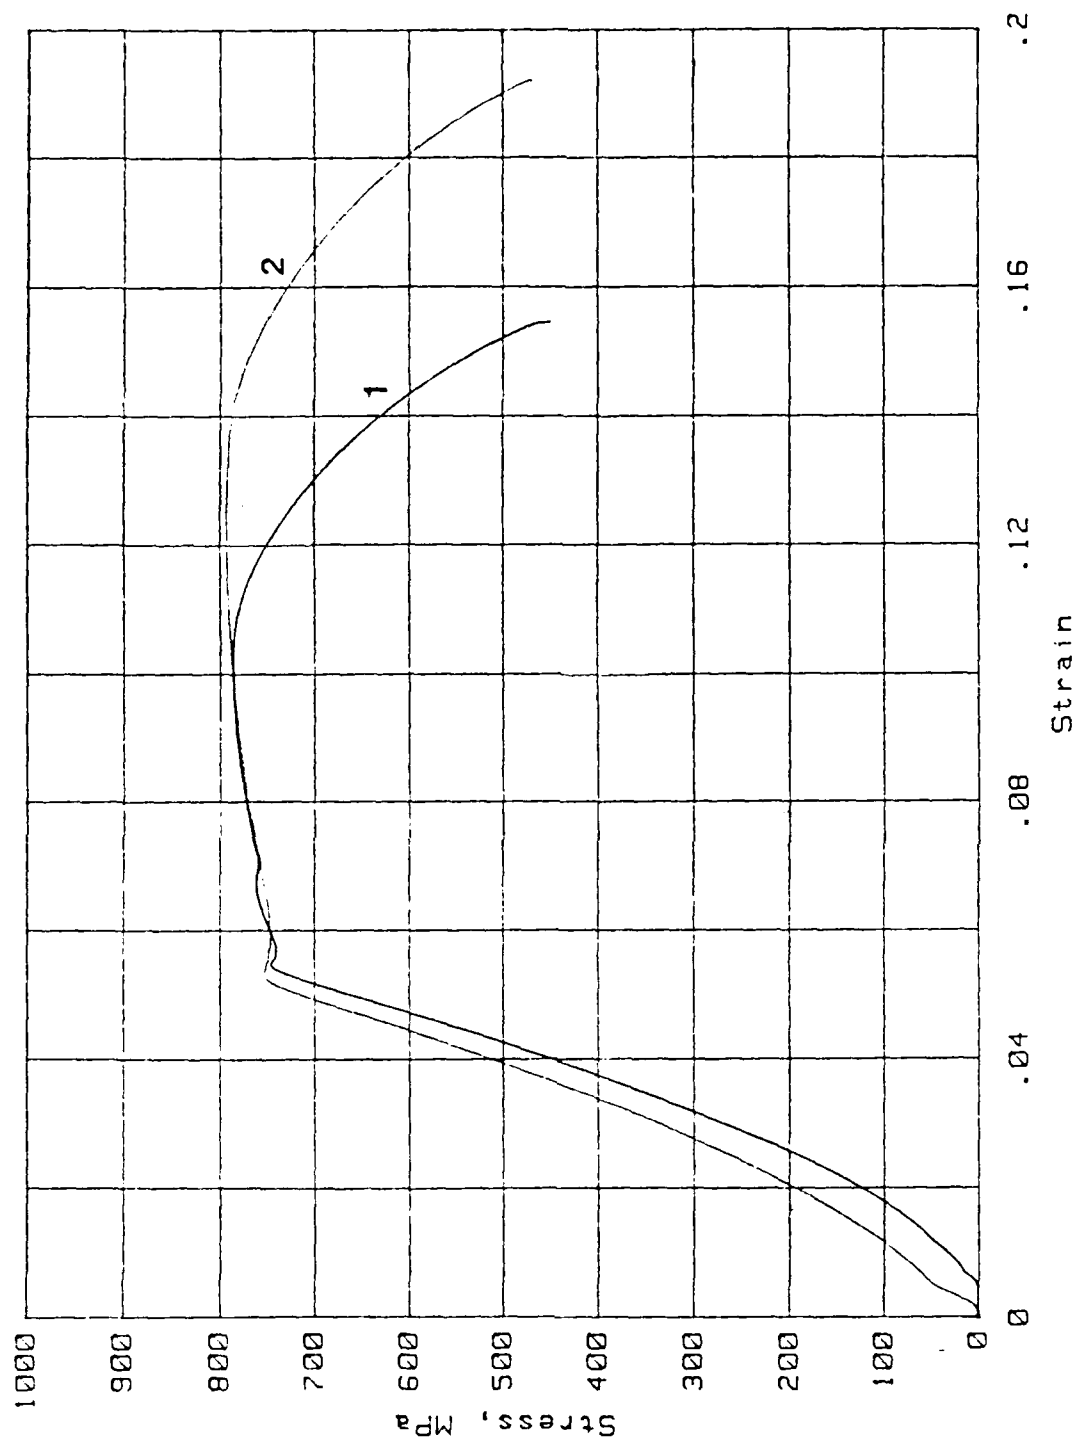
Figure 37. Room Temperature Stress Strain Curve  
for HSLA-100 Steel Weldments

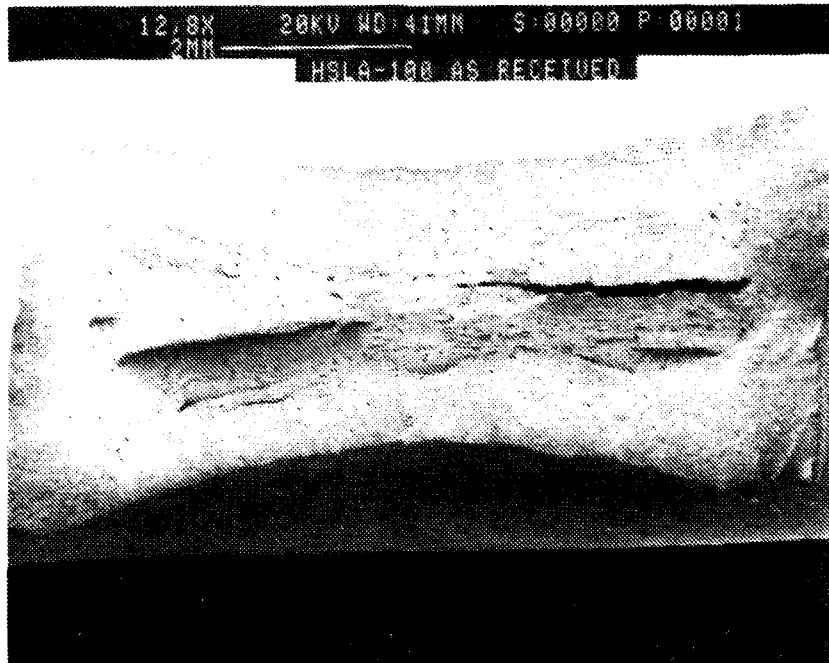
Figure 38. **SEM Low Magnification Fracture Surface of Flat Specimens, Fractured at Room Temperature in the Base Metal**

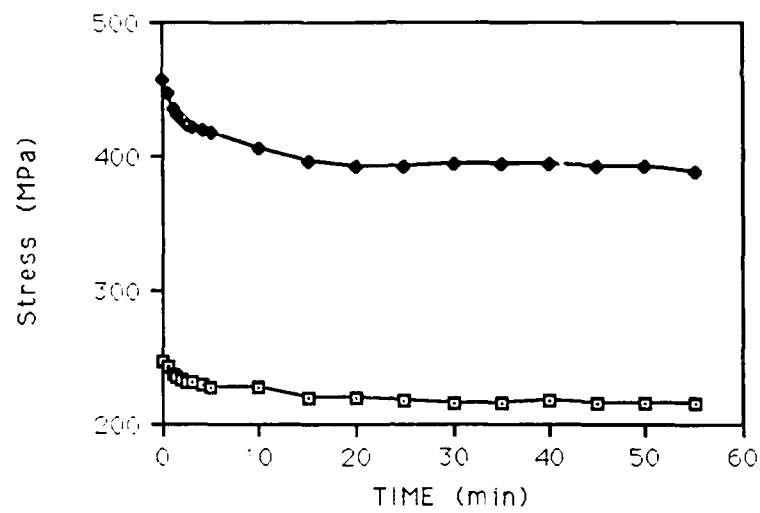
Figure 39. **Stress Relief Curves for Testing Conducted at 550° C**

The stress relief observed as a function of time is plotted, for the different test temperatures and initial stress levels, in Figures 39, 40, 41, and 42. The numerical data collected from the stress relief curves used for these plots is given in Table 3. A larger thermal relief rate was observed for the higher temperatures. The amount of stress relief was also observed to be a function of the applied stress because the decrease in the initial stress was higher for a larger initial load.

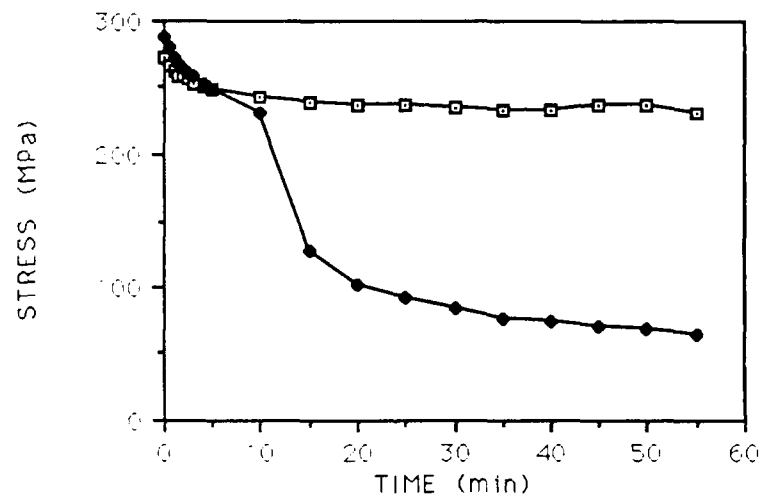
Figure 40. **Stress Relief Curves for Testing Conducted at 600° C**

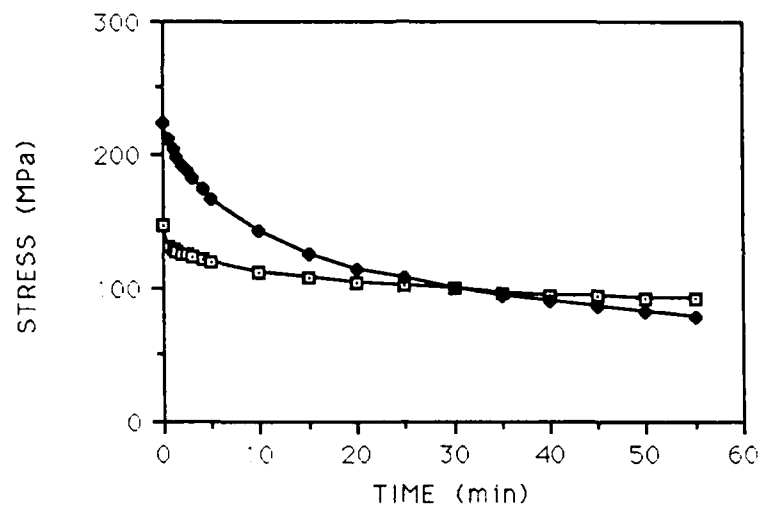
Figure 41. **Stress Relief Curves for Testing Conducted at 650° C**

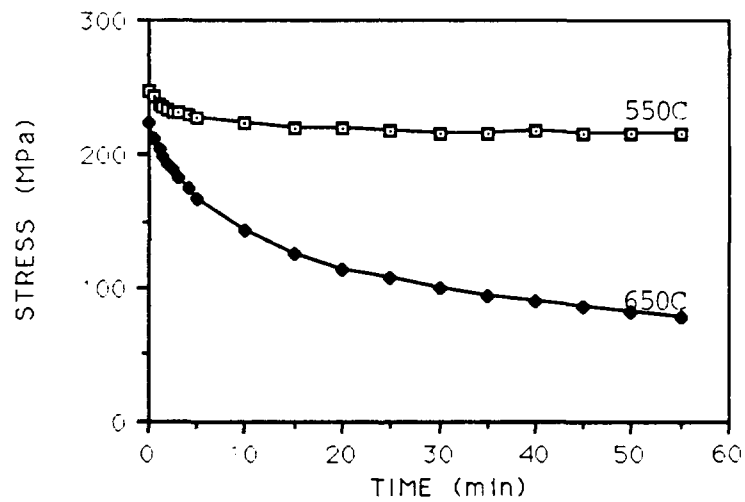
Figure 42. **Comparison of Stress Relief Curves for Two Different Test Temperatures**

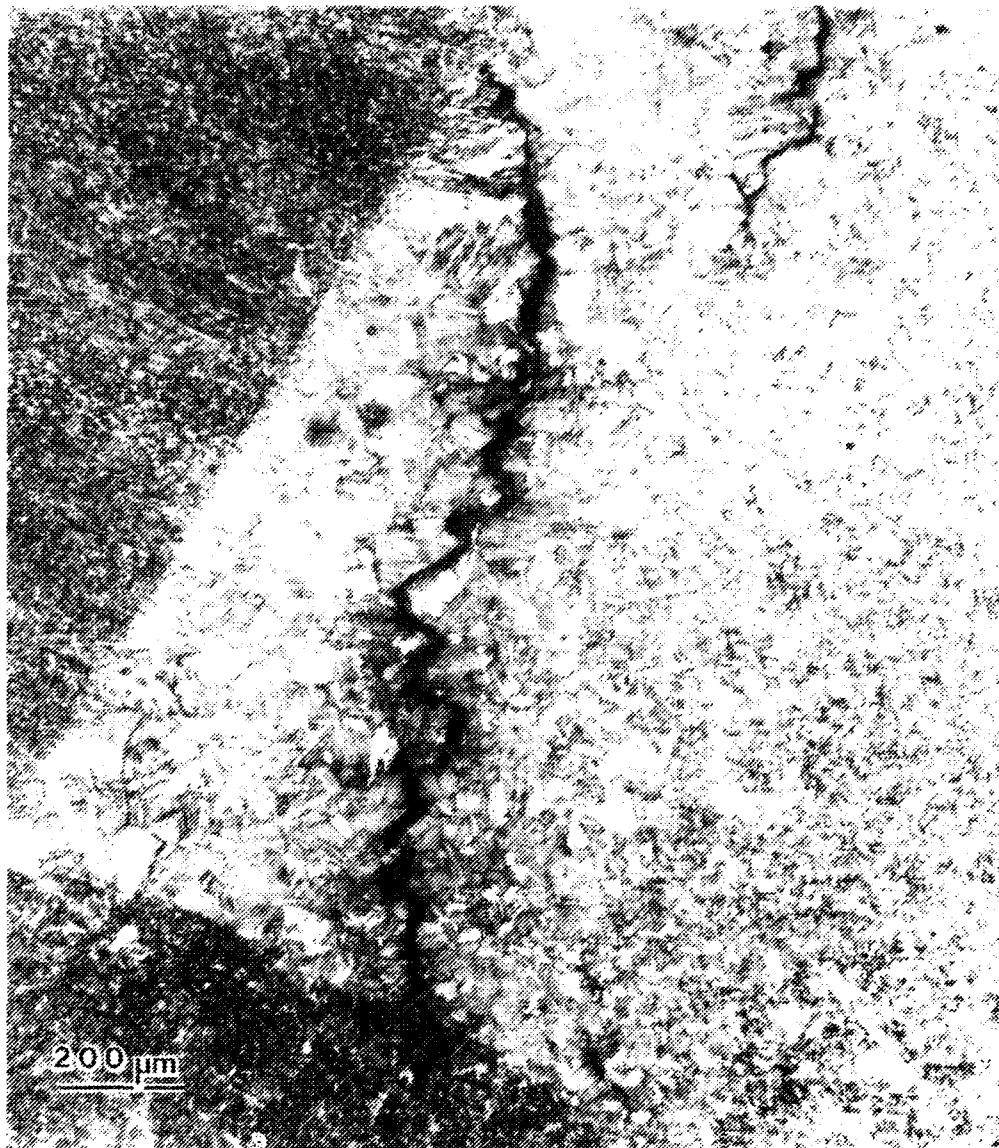
Figure 43. Crack Traversing the Coarse HAZ Perpendicular to the Load at a Test Temperature of 550° C

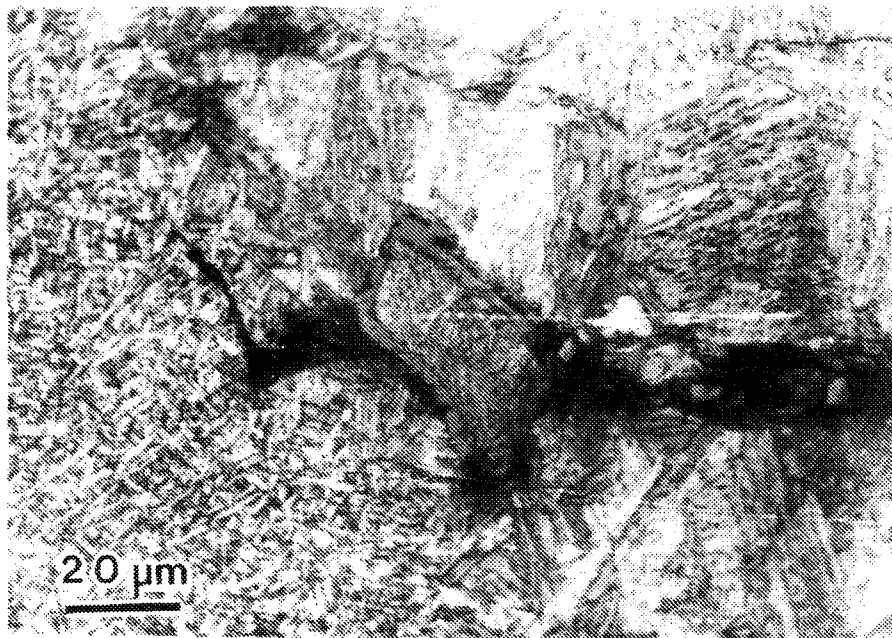
Figure 44. **Crack Branching After Stress Relieving at 550° C for One Hour**

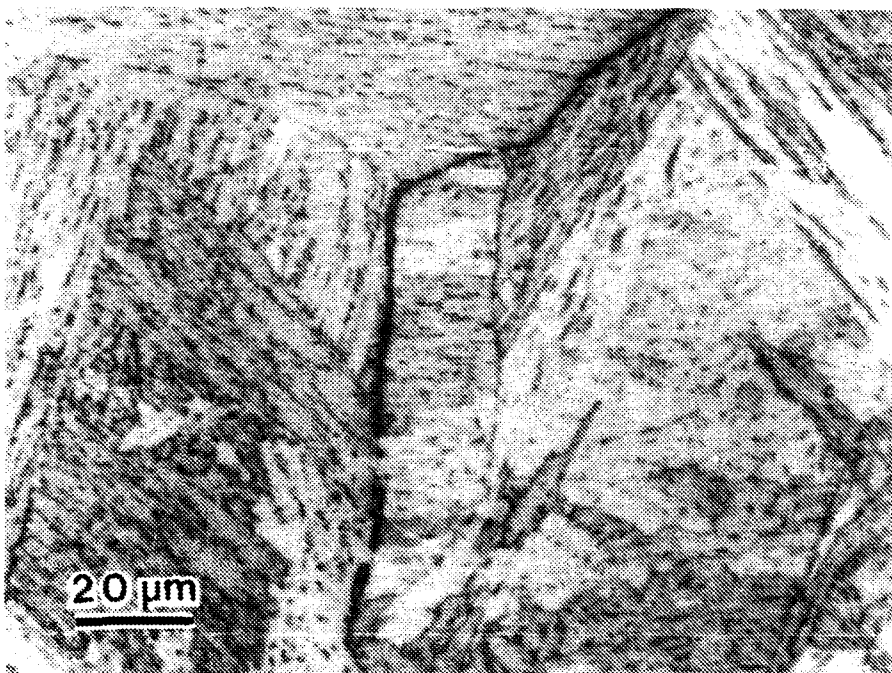
Figure 45. **Apparent Crack Discontinuities After Stress Relieving at 550° C**

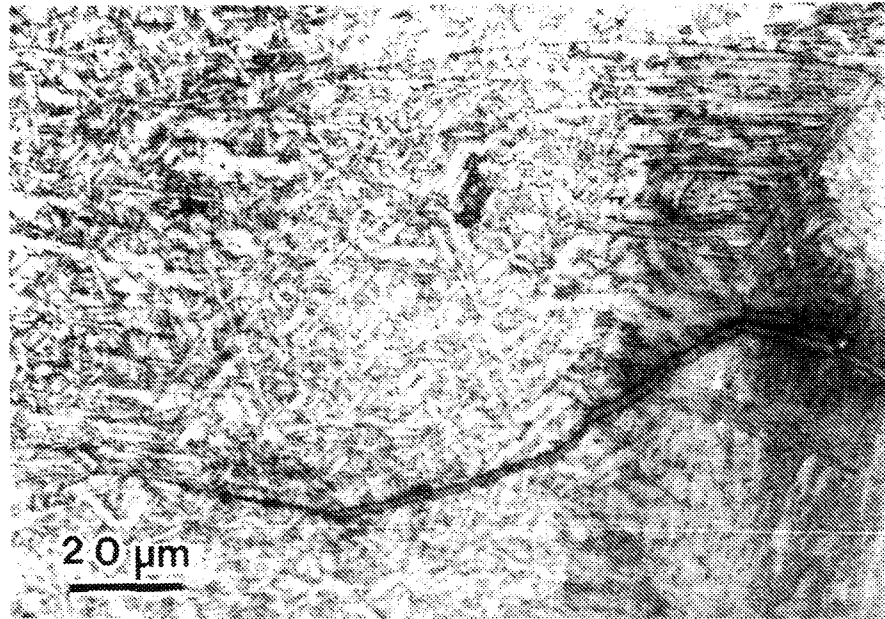
Figure 46. **Crack Penetration in the Weld Metal  
After Stress Relieving at 550° C**

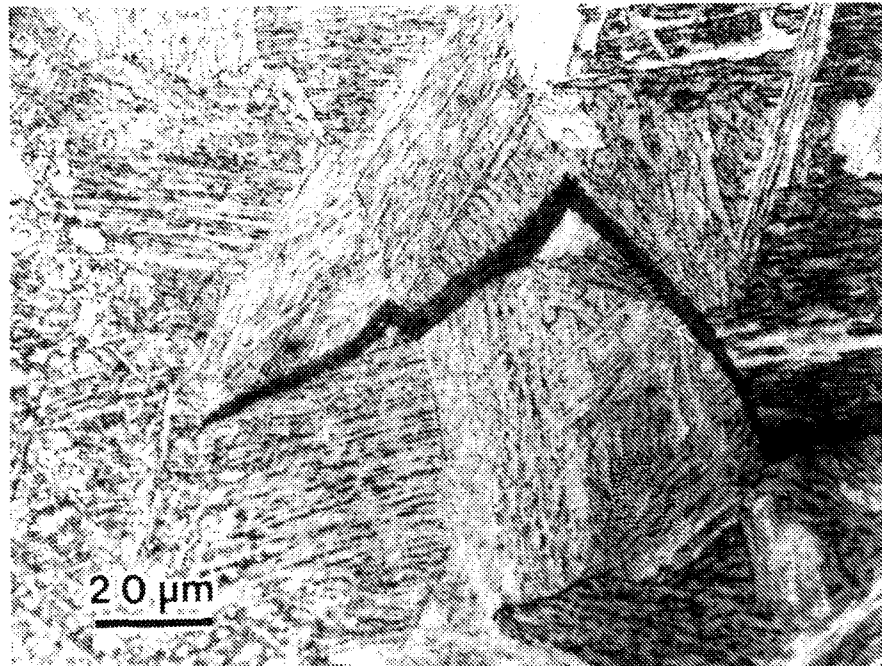
Figure 47. **Crack Arrested by the Weld Metal  
During Stress Relieving at 550° C**

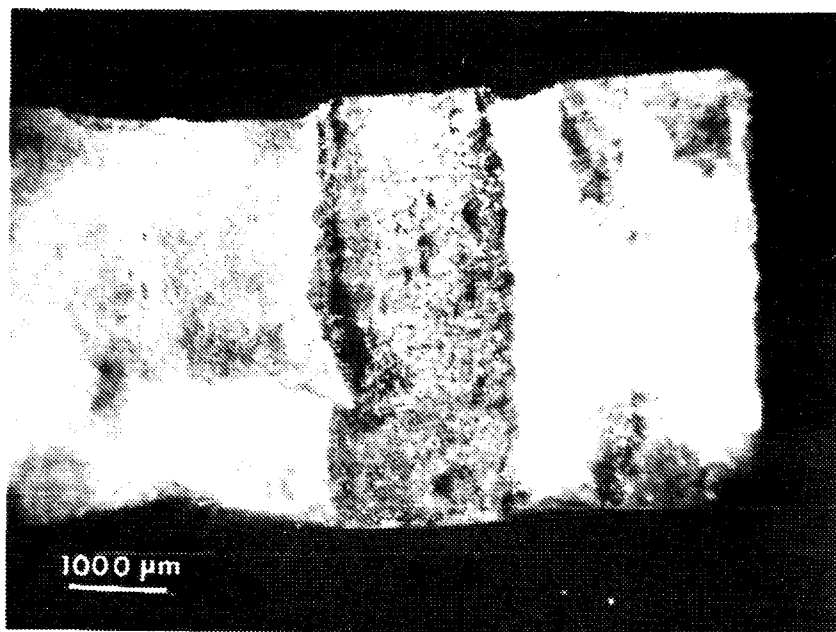
**Figure 48. Photograph of the Fracture Surface Illustrating Limited Lateral Plastic Flow in the Coarse-Grained HAZ**

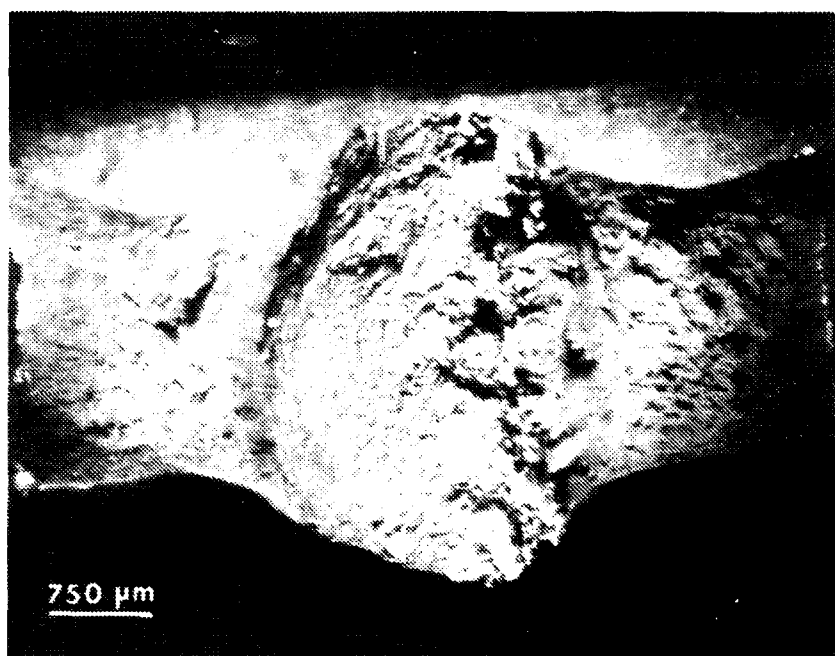
**Figure 49. Photograph of the Fracture Surface Illustrating More Plastic Flow in Areas Surrounding the Coarse-Grained HAZ**

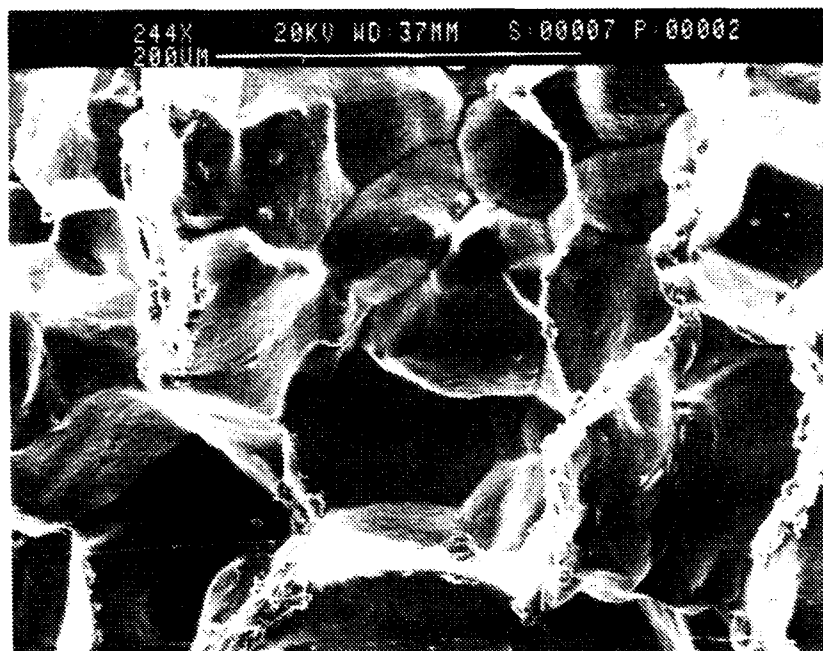
**Figure 50. SEM Micrograph Showing a Fracture Surface in the Coarse-Grained HAZ After Stress Relieving for One Hour at 550° C**

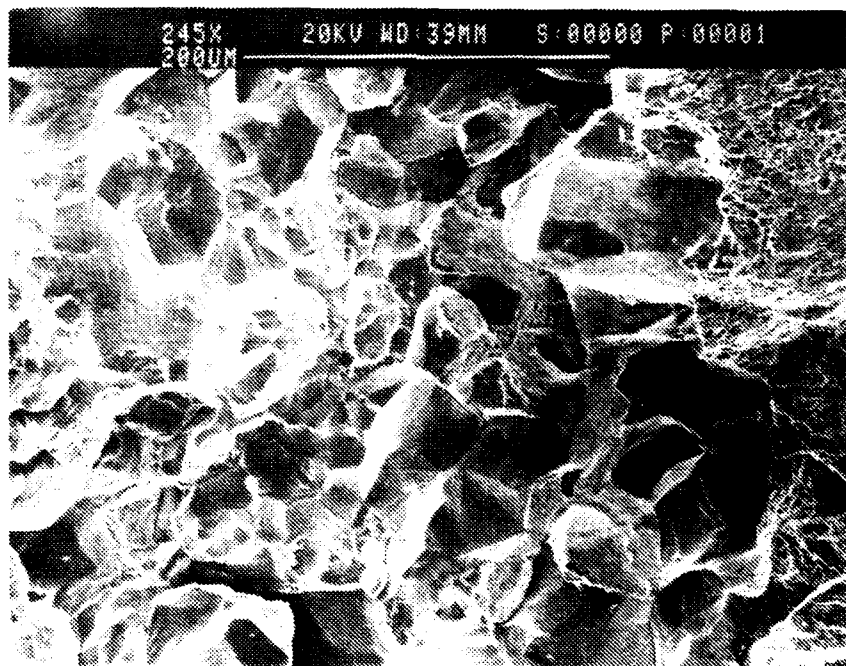
**Figure 51. SEM Micrograph of the Fracture Surface in the Coarse-Grained HAZ After Stress Relieving for One Hour at 600° C**

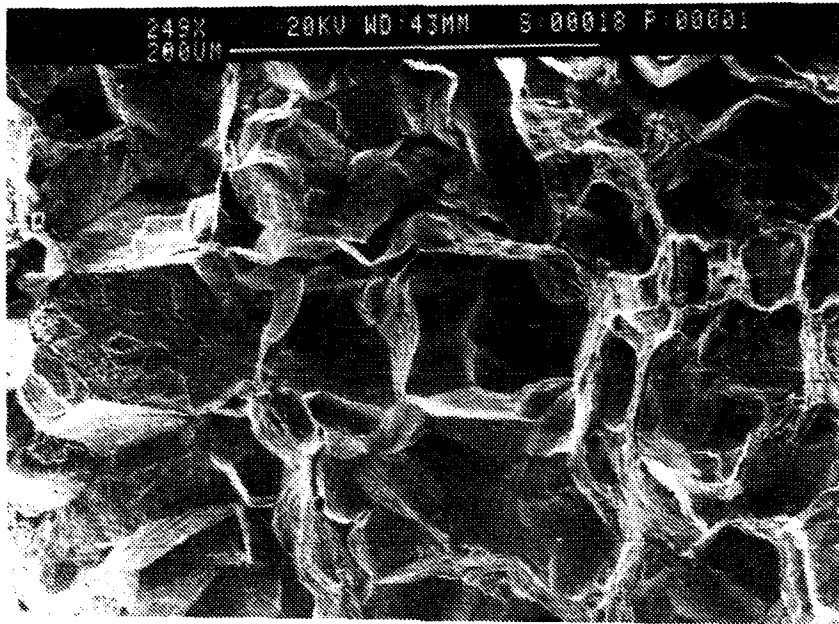
Figure 52. **SEM Micrograph of the Fracture Surface in the Coarse-Grained HAZ After Stress Relieving for One Hour at 650° C**

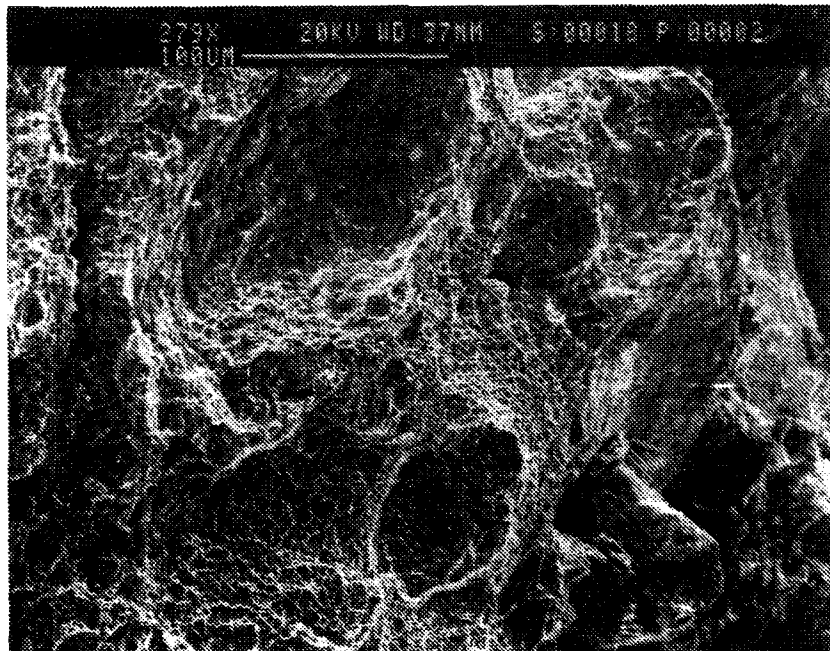
Figure 53. **SEM Micrograph Illustrating Ductile Fracture Typical of Certain Areas of the Fracture Surfaces At All Test Temperatures**

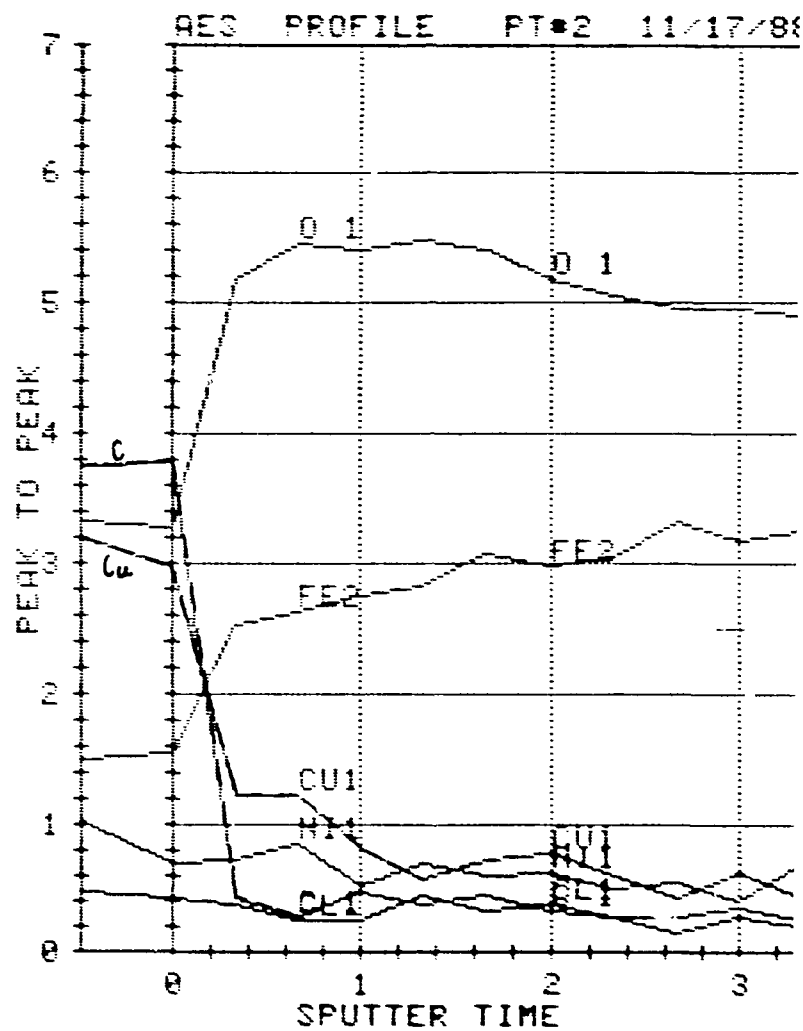
Figure 54. AES Depth Profile on the Grain Boundary Face of Specimen 1

The Auger analysis was primarily performed in the survey and profile modes. Specimen 1 indicated significant carbon, nickel, and copper concentrations on the fracture surface along with spherical Si particles. The depth of these concentrations in Specimen 1 was estimated to be less than 100 Å (Figure 54), while Specimen 2 showed a depth of 400 Å. Specimen 2 indicated the presence of S, Cl, N, O, Fe, and Cu (Figure 55). Copper was found everywhere on the fracture surface, with concentrations on the grain boundary facets and grain boundary edges.

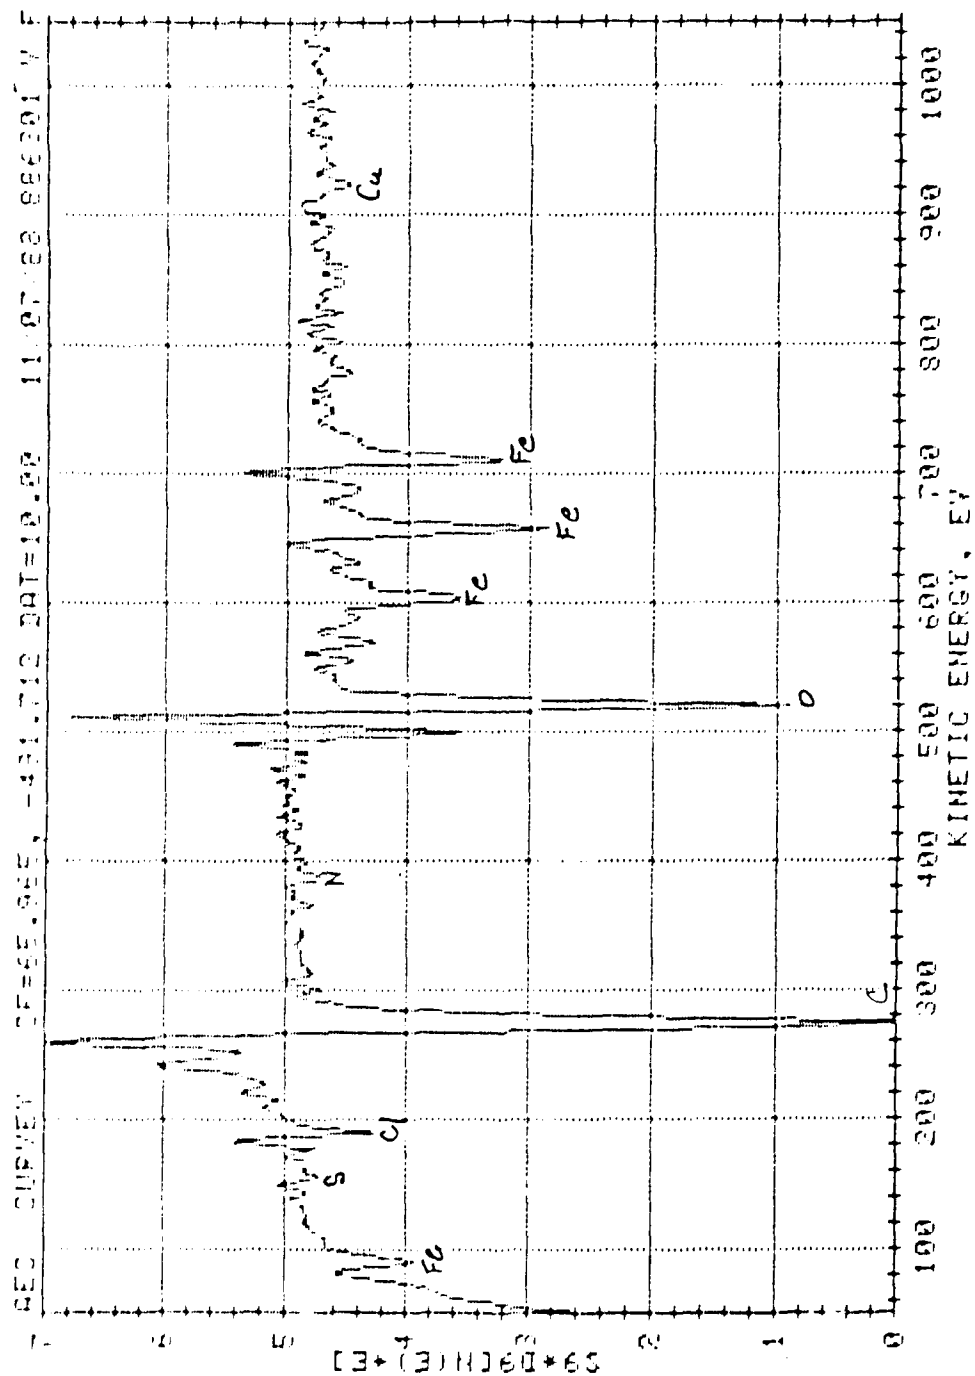
Figure 55. AES Survey Showing the Elements Present  
 on the Fracture Surface of Specimen 2

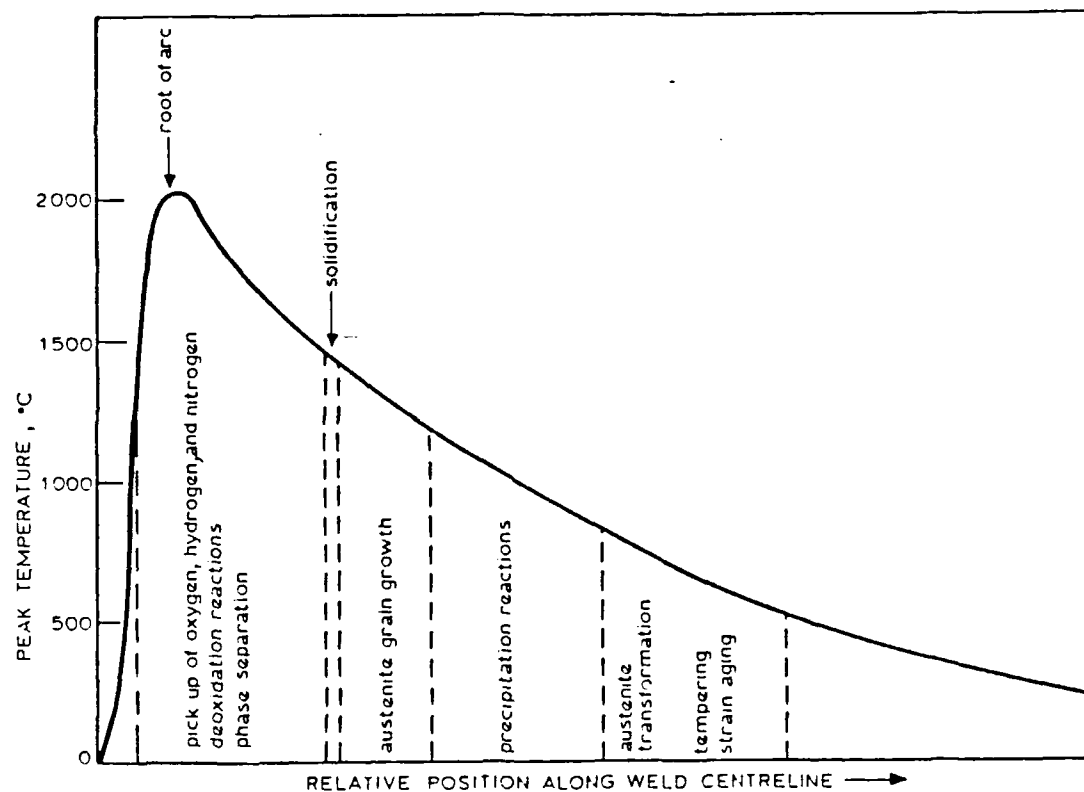
Characteristic temperature ranges where specific chemical and physical reactions occur during cooling of weld metal down to room temperature are also indicated.
